## **ENGINEERING ASSESSMENT OF STRUCTURES AT THE OLD BURYING GROUND STONEHAM, MASSACHUSETTS**

### **STRUCTURES AT THE OLD BURYING GROUND**

## Cemetery Structures Inspection Report

May 25, 2012

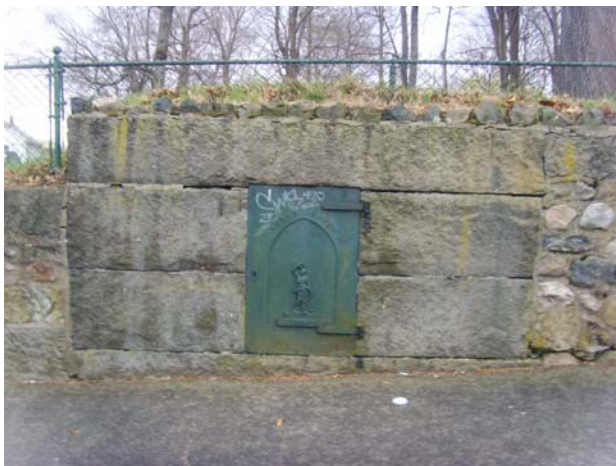
Peter Green Tomb  
Dated 1855

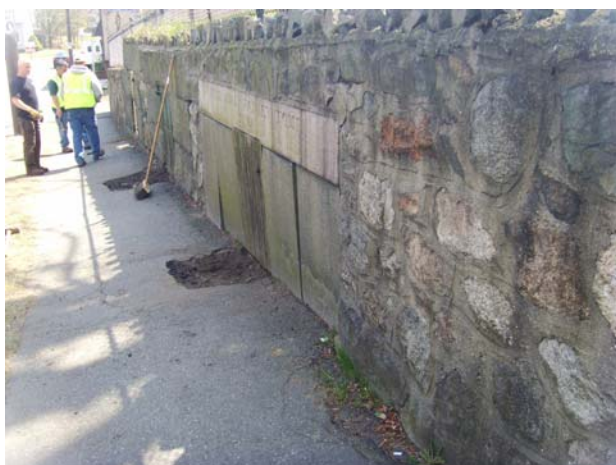
James Hill's Family Tomb  
Dated 1836

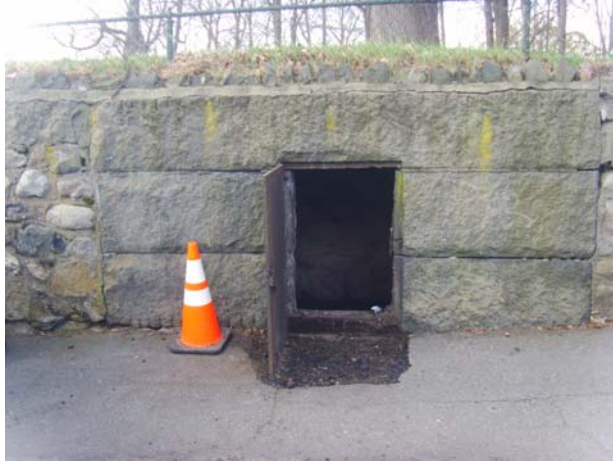
Town Receiving Tomb  
Dated ca. 1845

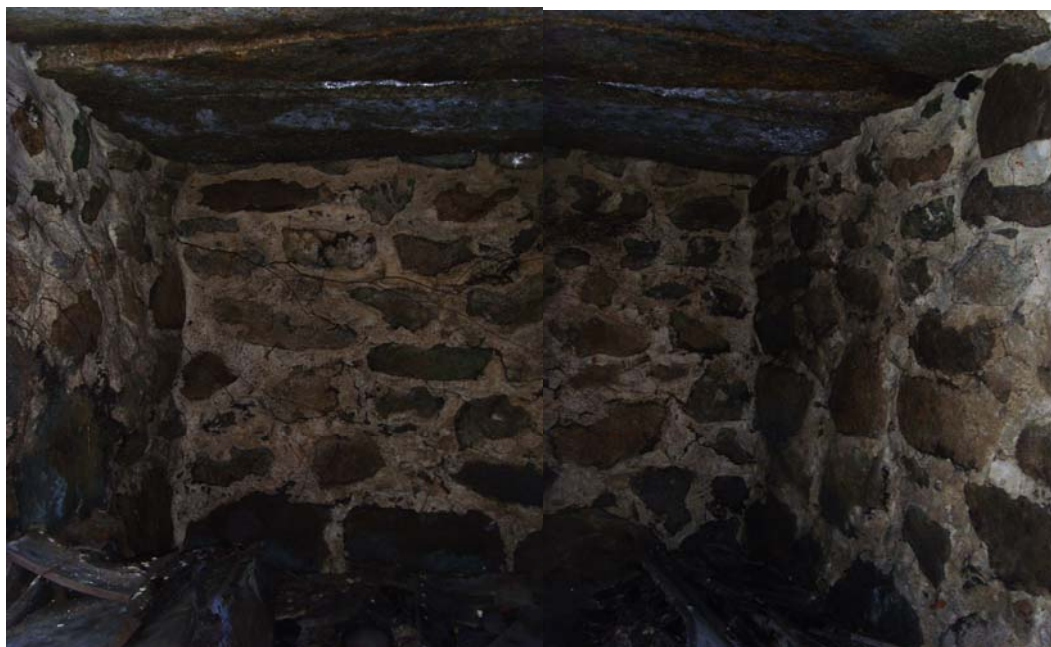
Composite Photo of the Interior of the Hill Tomb

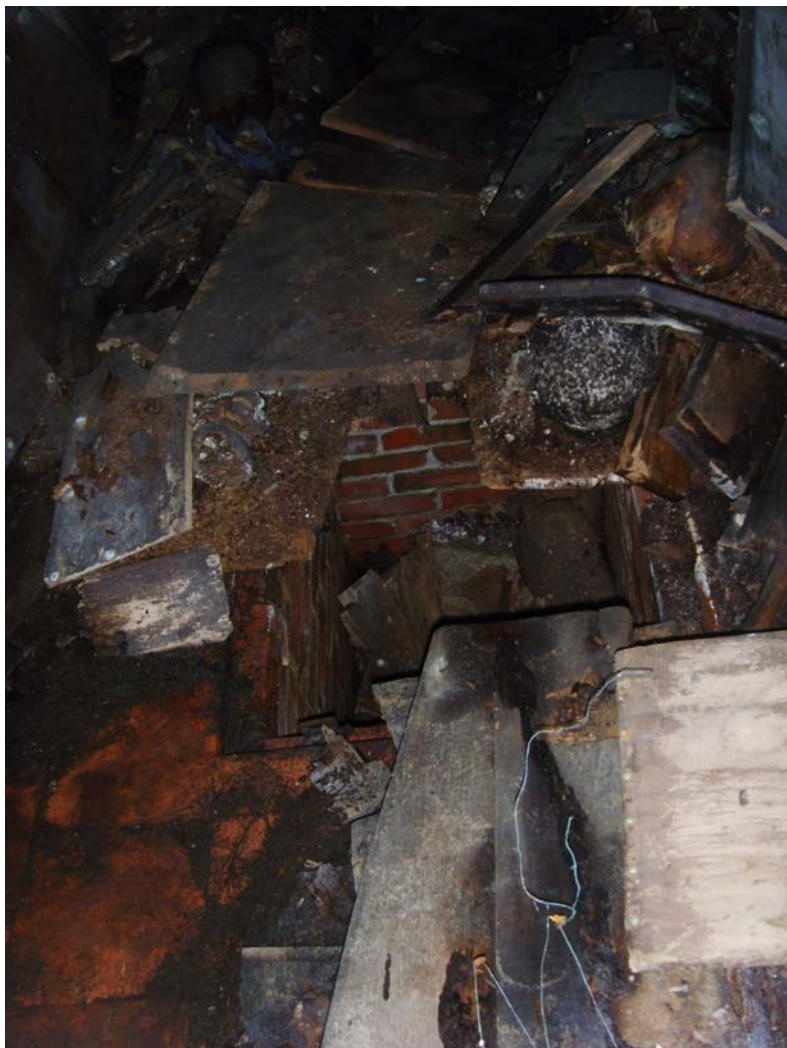
Floor of the Hill Tomb showing Clay Tile (to left) and Brick Well (center)

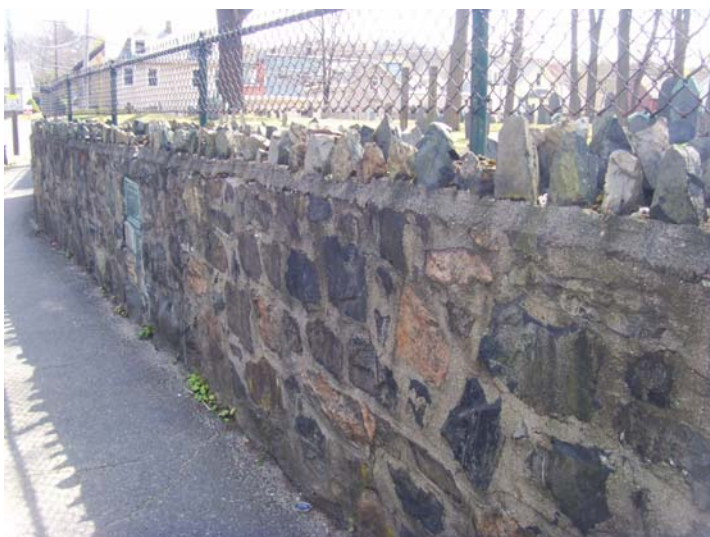
Pleasant Street Wall

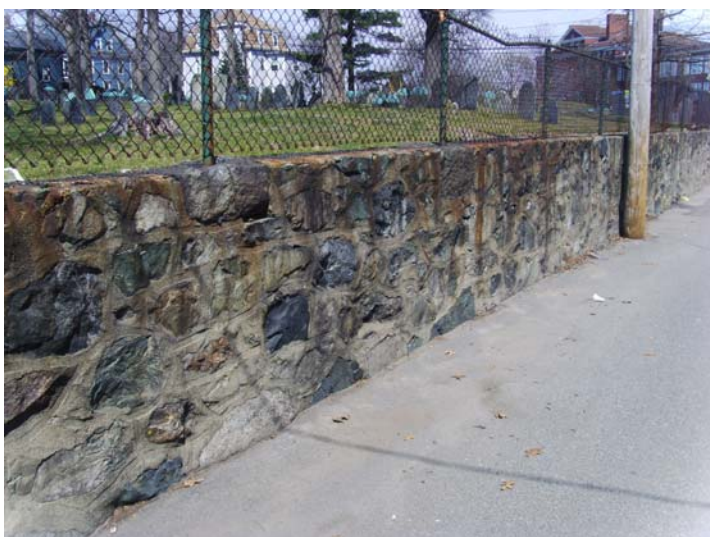
Oriental Court Wall

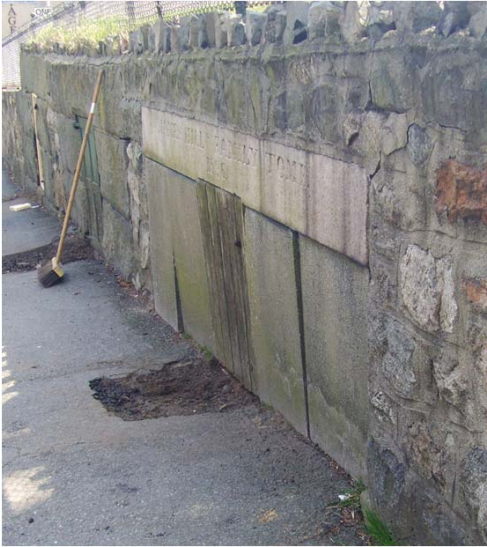
<p style="text-align: center;">Photo 1</p>

<b>Structure</b>	
James Hill's Family Tomb (Exterior)	
<b>Inspection Items</b>	<b>Comments</b>
Movement	All façade stones are leaning and shifting. There is a significant lean of 3" toward the street.
Door	The original door has been replaced. A wood door was found inside the tomb. It may not be the original door, but it could be a replica of the original door. It is a flat wood door with no significant ornamentation or detail. The original hinges and lockset bolt recess can be seen. See Photo 4.
Joints	Many of the joints are open See Photo 1. The original joints were not mortared. This was verified from the inside as well.
Staining	Minor staining. See Photo 1.
Plant Growth	Minor Lichen growth See Photo 1.
Overall Condition	Fair to Poor
Short Term Repairs	Clean Front Exposed Surfaces
Long Term Repairs	Remove and reset front façade Install drainage behind façade stones Replicate and install new door. Remove jagged stoned on top of headstone

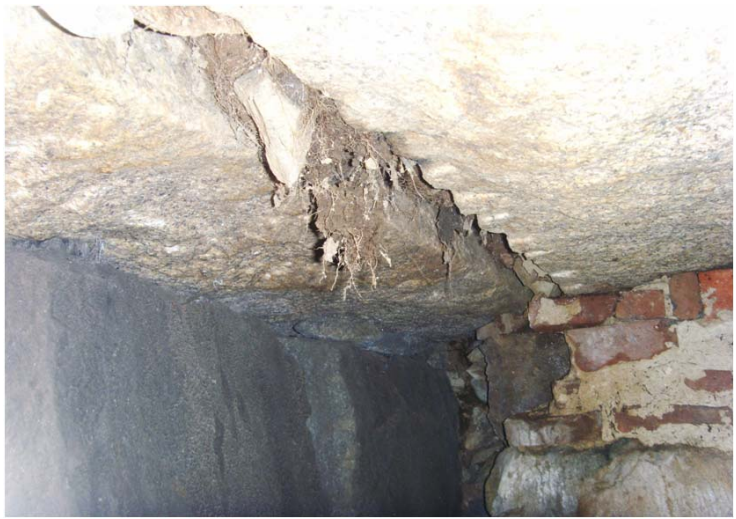
<p>Photo 1</p>
  <p>Photo 2</p>

<b>Structure</b>	
James Hill's Family Tomb (Interior)	
<b>Inspection Items</b>	<b>Comments</b>
Movement	Side and rear walls are stable Roof stones are stable Front façade has moved forward approximately 3", which has led to large opening in the corners and between the roof stones. Large amounts of soil have fallen into the front of the tomb. See Photo 1.
Dimensions	The interior dimensions of the tomb are as follows: Front to back: 13 feet Side to side: 8 feet Floor to ceiling: 6 feet Front wall thickness: 12" (granite)
Joints	The interior joints are all mortared. This may be an original condition. The front façade wall is not mortared.
Staining	Minor staining and moisture.
Floor	Unusual tile floor (8"x8" clay) Appears to be dry laid. There is an unusual sump pit in the middle of the tomb. It is 19"x32" and 24" deep. It is constructed with brick and may have been added as a dry well? See Photos 4 and 5.

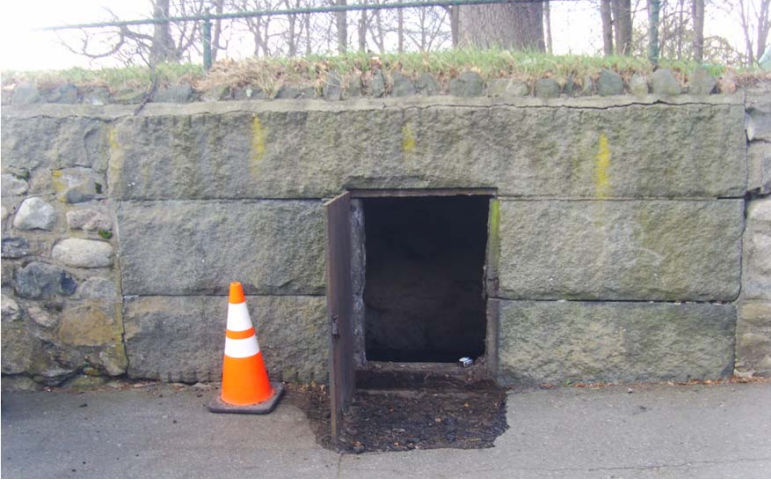
<p>Photo 1</p>
<div style="display: flex; justify-content: space-around;">

<b>Structure</b>	
Town Receiving Tomb (Exterior)	
<b>Inspection Items</b>	<b>Comments</b>
Movement	The front façade is leaning slightly forward. toward the street. See Photo 3.
Door	The hinges are heavily rusted. The door is in fair condition. It has been repainted. The lockset was corroded beyond repair.
Joints	Most of the joints are open to some degree. See Photo 1. The original joints were not mortared. The existing mortar is only partial depth. This was verified from the inside as well. See Photo 3.
Staining	Minor staining and graffiti. See Photo 1.
Plant Growth	Minor Lichen growth See Photo 1.
Overall Condition	Good
Short Term Repairs	Clean Front Exposed Surfaces
Long Term Repairs	Remove and reset front façade Install drainage behind façade stones Restore door and reset Remove jagged stoned on top of headstone

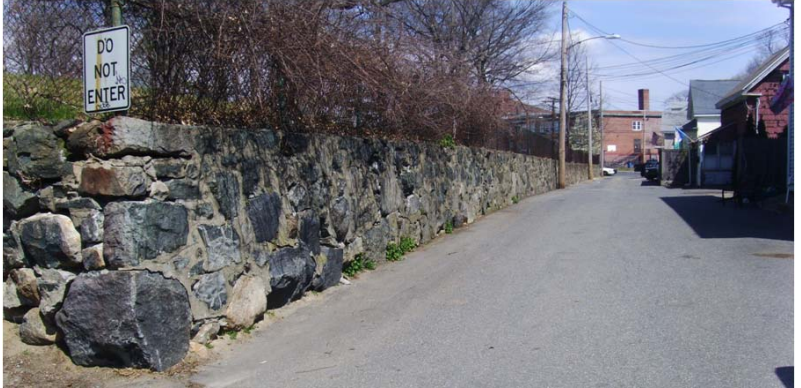
Photo 1

<b>Structure</b>	
Oriental Court Retaining Wall	
<b>Inspection Items</b>	<b>Comments</b>
Movement	Minor if any Most of the wall is very plumb and stable There is a crack near the corner caused by minor movement of the return wall. (just to the right of the "do not enter sign" in photo 1). Photo 3 also shows the crack.
Joints	The return wall near the adjacent building has rough joints with missing mortar. The joints in the main wall are smooth and made with cement based mortar. There is lime based mortar below the cement mortar, which most likely the original mortar. Photo 2 shows the two layers of mortar since the cement mortar has fallen away. Most of the joints are in fair to good condition. Many joints at the base of the wall are missing mortar. This is most likely due to snow plows or water.
Staining	There is staining from the corrosion of the chain link fencing. See Photo 4.
Plant Growth	There is significant plant growth on the fence near the far end. See Photo 1.

Fencing	The fencing is not original (added in 1937). The stones at the base of the posts do not the other stones in size and shape. They are larger and squared off. They were part of the original wall; however they supported an older fence (Town records).
Drainage	There are no signs of weep holes of foundation drains. There are areas behind the wall that can collect water; however there are no signs that this has caused distress to the wall.
Overall Condition	The wall is in very good condition considering the age. The wall is true and plumb with little sign of movement or settlement. The fencing is corroded and damaged.
Short Term Repairs	Repair and paint fence posts and rails. Replace chain link fabric. Repair damaged and missing pointing. Remove rust staining.
Long Term Repairs	Repoint entire wall with historic mortar Clean all surfaces Remove fence and install a new historically accurate fence.

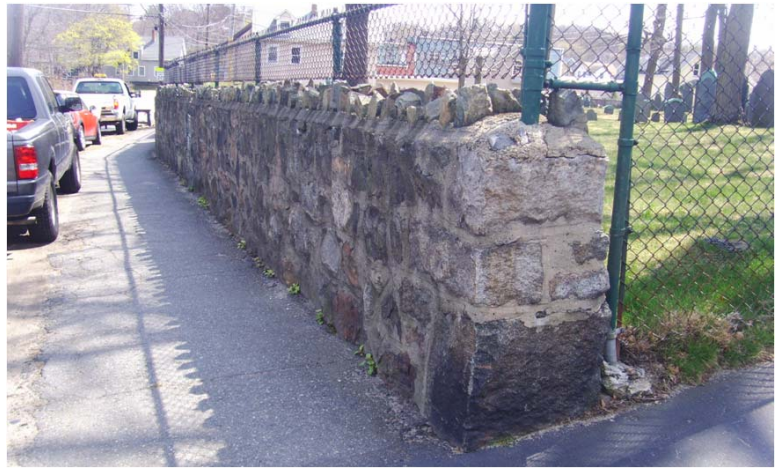
Photo 1

<b>Inspection Items</b>	<b>Comments</b>
Movement	None Most of the wall is very plumb and stable There is a crack near the Oriental Court corner caused by minor movement of the wall.
Joints	The joints are smooth and made with cement based mortar. There is lime based mortar below the cement mortar, which is most likely the original mortar. See Photo 2 shows the two layers of mortar since the cement mortar has fallen away. Most of the joints are in fair to good condition.
Staining	There is staining from the corrosion of the chain link fencing.
Plant Growth	There is significant plant growth on the fence near the far end. See Photo 1. There is minor lichen and moss growth.
Fencing	The jagged stones on top of the wall do not appear to be original. They do not match the details on the Oriental Court wall and the mortar used to adhere the stones is cement based. The fencing is not original (see notes on the Oriental Court Wall). The gate is corroded and damaged, but still functional.

Drainage	There are no signs of weep holes of foundation drains. There are areas behind the wall that can collect water; however there are no signs that this has caused distress to the wall.
Overall Condition	The wall is in very good condition considering the age. The wall is true and plumb with little sign of movement or settlement. The fencing and gate are corroded and damaged.
Short Term Repairs	Repair and paint fence posts, gate and rails. Replace chain link fabric. Repair damaged pointing. Remove rust staining.
Long Term Repairs	Repoint entire wall with historic mortar Clean all surfaces Remove fence and install a new historically accurate fence. Remove jagged stone.
